# EPBC Ecological Clearance Report

**Document No:** 1175-ECO-CLR-001-1.0

**Project No and Name:** 1175 – Marinus Link

**Subject:** EPBC Pre Clearance Report – Early Works Access point

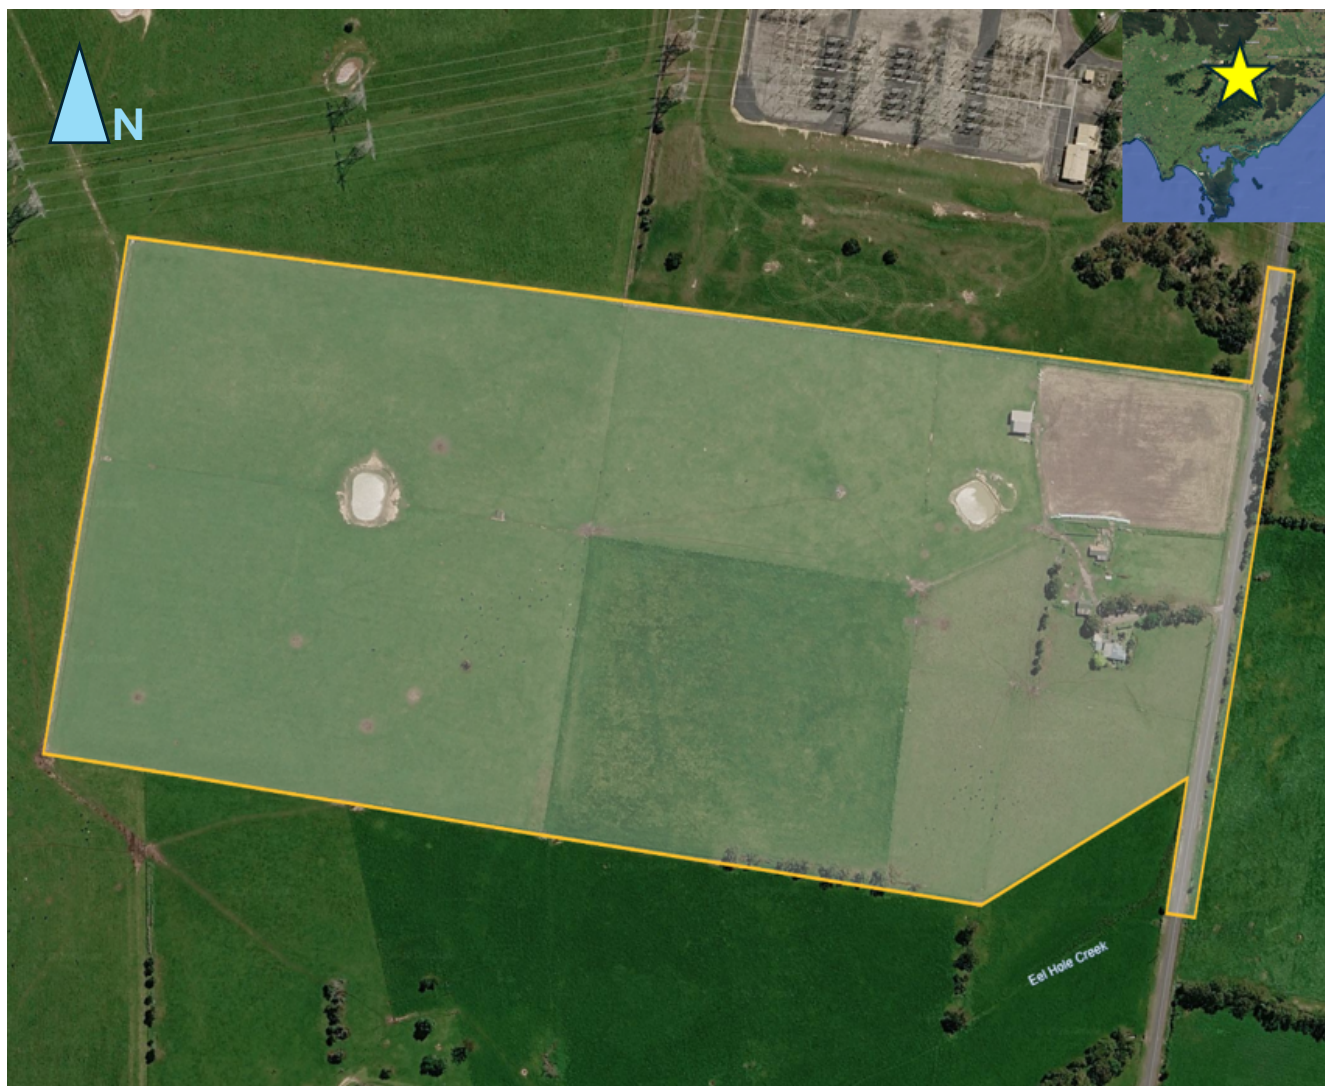
**Map 1.** EPBC Pre Clearance area (yellow shaded zone). Not to scale.

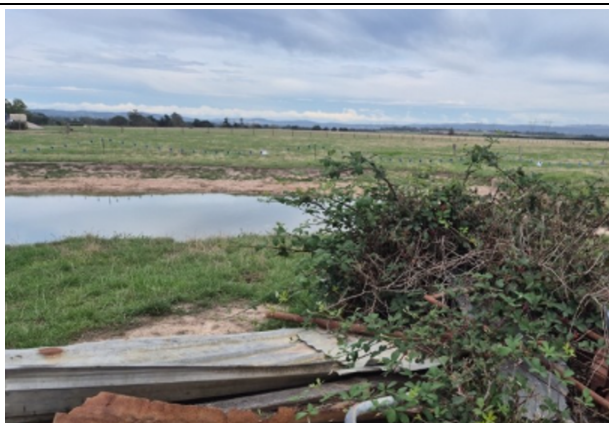
**Figure 3.** Severe erosion, rubbish and cattle pugging around edge of a dam.

| 8. Follow-Up | |
|---|---|
| Further comments/conclusions | Clearing of the pasture on V0623 can occur without ecological supervision because this area is highly degraded, offers very limited fauna habitat and is unlikely to support reptiles or amphibians. An ecologist must be present when the trees on the V626 roadside parcel and in the shelterbelts/driveway are cleared as these trees contain multiple hollows and there is potential for nests or dreys to have been built within vegetation after this pre-clearance report has been written. Ecological supervision is also required during any dewatering of the dams on V0623, as standing water may support aquatic or semiaquatic species that need to be detected and safely relocated. |

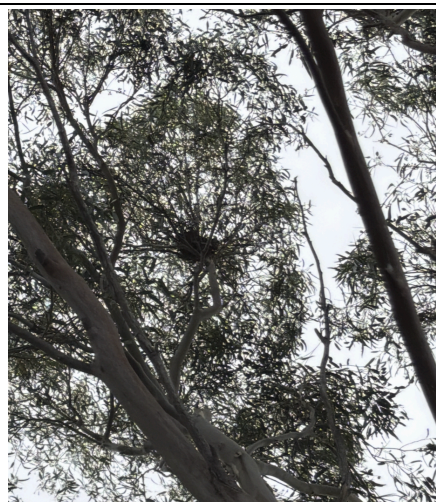
Nest identified 12<sup>th</sup> May 2026: Likely to that of a Raven or Australin Magpie
